## Protect Streambanks with Trees

SRL 122

October 1998

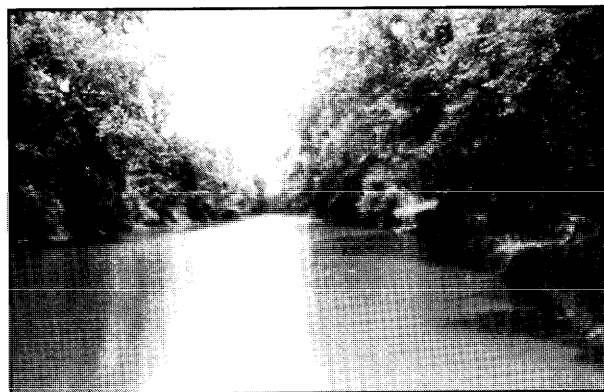
**Figure 4. Natural woody vegetation should be left to protect streambanks.**
